**Flood Control Project Maintenance  
Levee Inspections**

**Fall 2010 Levee Maintenance Deficiency Summary Report**

**Sutter Maintenance Yard Nelson Bend**

Waterway						Bank	Unit Miles	Inspection Start/End	Inspector
Unit No. 01 Feather River West Levee-Nelson Bend							0.50	11/09/2010 11/09/2010	Clay Thomas

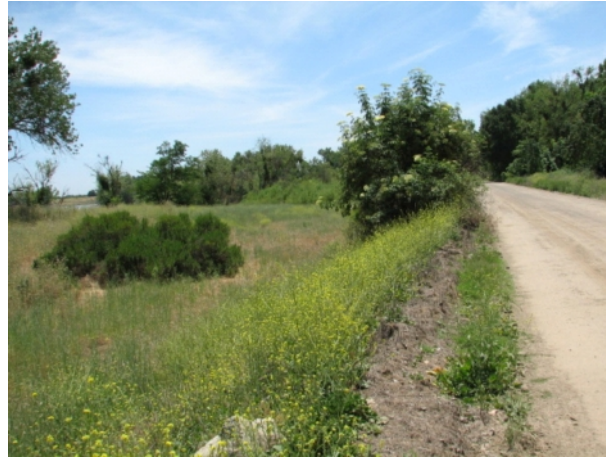
cathom\_f\_20100928\_050.jpg

Levee Mile Report Line	1
Start Levee Mile	0.01
End Levee Mile	0.45
Location	Water Side
Category	Earthen Levee
Item	Vegetation

Water side vegetation levee mile 0.01.

LMR No.	Levee Mile		Category	Item	* Location	** Rating	Action/Comment	GPS Latitude/Longitude		Issue No.
	Start	End						Start	End	Photo
1	0.01	0.45	Earthen Levee	Vegetation	WS	M	Remove the wild growth other than native grasses from the levee slopes.	38.886940 ° -121.614755 °	38.880855 ° -121.614555 °	2 Y
2	0.01	0.45	Earthen Levee	Vegetation	LS	M	Remove the wild growth other than native grasses from the levee slopes.	38.886937 ° -121.614752 °	38.880822 ° -121.614565 °	1 Y
3	0.01	0.45	Earthen Levee	Trim / Thin Trees	LS	M	Thin trees to allow visibility of the ground and room to flood fight.	38.886933 ° -121.614753 °	38.880857 ° -121.614555 °	3
4	0.05	0.05	Earthen Levee	Vegetation	WS	M	Elderberries are blocking visibility and flood fight capability.	38.886408 ° -121.615092 °	38.886408 ° -121.615092 °	4
5	0.13	0.22	Earthen Levee	Vegetation	WS	M	Elderberries are blocking visibility and flood fight capability.	38.885320 ° -121.615677 °	38.883970 ° -121.615830 °	5

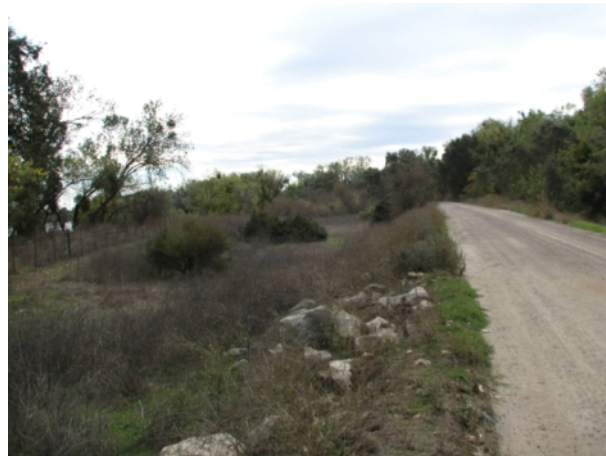
cathom\_f\_20101115\_195.jpg

Levee Mile Report Line	1
Start Levee Mile	0.01
End Levee Mile	0.45
Location	Water Side
Category	Earthen Levee
Item	Vegetation

Levee mile 0.00, water side vegetation.

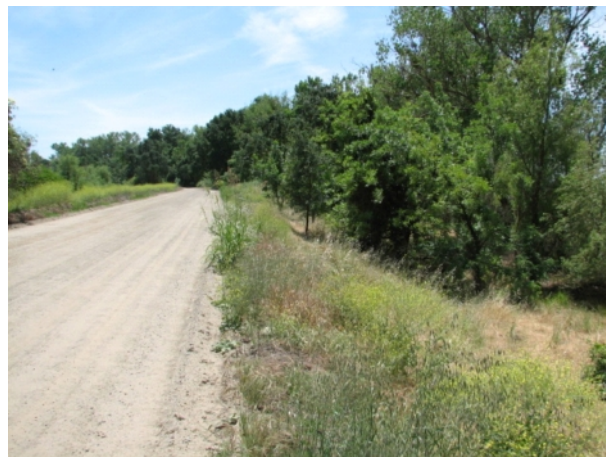
cathom\_f\_20100928\_049.jpg

Levee Mile Report Line	2
Start Levee Mile	0.01
End Levee Mile	0.45
Location	Land Side
Category	Earthen Levee
Item	Vegetation

Land side vegetation levee mile 0.01.

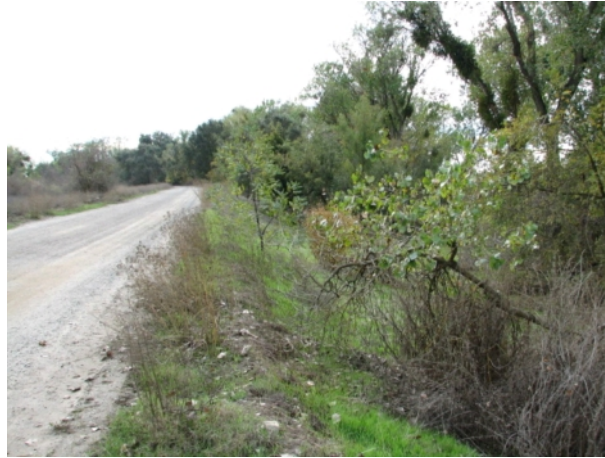
Levee Mile Report Line	2
Start Levee Mile	0.01
End Levee Mile	0.45
Location	Land Side
Category	Earthen Levee
Item	Vegetation
Levee mile 0.00, land side vegetation.	
cathom_f_20101115_196.jpg
